# **PENN BRANCH**

## **TRAFFIC-CALMING STUDY**

Submitted By:  
KLS Engineering  
21525 Ridgetop Circle, Suite 140  
Sterling, VA 20166  
(703) 444 7686

April 2008

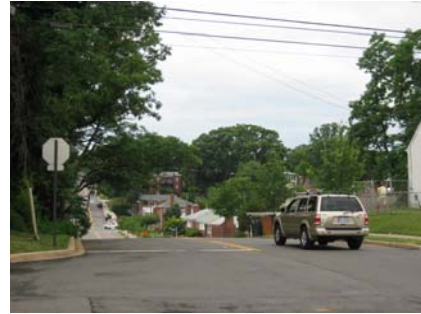
**Figure 7: 30th Street - Poor Visibility**

**Geometry:** It is a two-way, one-lane street, with a road width approximately of 32 ft. The horizontal and vertical alignments of 30<sup>th</sup> Street are straight and somewhat undulating, with curb radii generally 15 to 25 ft. Figure 7, illustrates poor visibility of the intersection with N Street.

ISSUE	SHORT-TERM RECOMMENDATIONS	LOCATIONS
<b>Landscaping</b>	Trim trees	<ul style="list-style-type: none"> <li>On 30<sup>th</sup> Street, between Anacostia Road and Nelson Street, shown in Figure 6</li> </ul>
<b>Evaluation:</b>		
1. Will improve visibility.

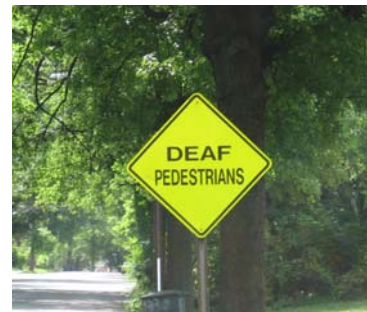
**Figure 8: Deaf Pedestrian sign**

The study area has some unique needs, as shown in figure 8, located at the intersection of Nelson Street and O Street.

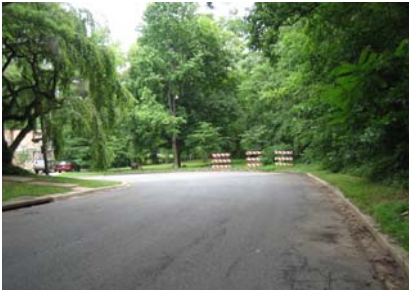
**Figure 9: Blind curve on Highwood Drive**

Figure 9 illustrates poor visibility along Highwood Drive caused by a curve in the horizontal alignment.
