# **PENN BRANCH**

## **TRAFFIC-CALMING STUDY**

Submitted By:  
KLS Engineering  
21525 Ridgetop Circle, Suite 140  
Sterling, VA 20166  
(703) 444 7686

April 2008

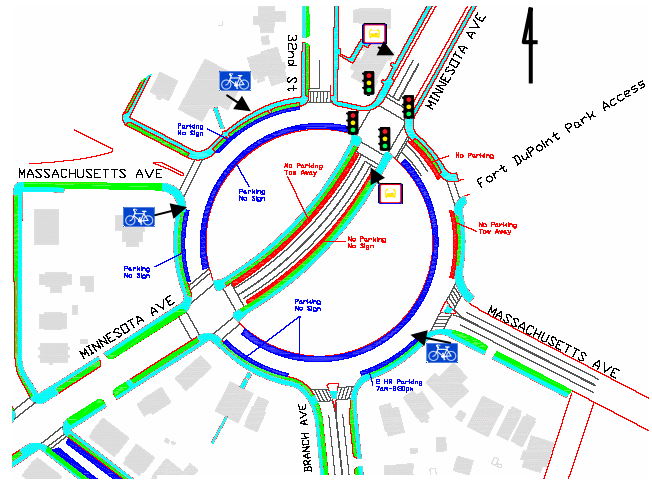
Figure 2: Randle Circle

**Parking:** At the time of our site visits, parking was permitted around Randle Circle (outer lane), except between Massachusetts Avenue and Minnesota Avenue. Between Branch Avenue and Massachusetts Avenue, parking was restricted to a 2-hour period and permit holders. No parking was permitted on either side of Minnesota Avenue inside of Randle Circle, as figure 2 shows.

***Pedestrian and Bike Facilities:*** Both transverse (parallel lines) and high-visibility crosswalks are used at the approaches and around Randle Circle, as figure 2 illustrates. The Circle has a good network of sidewalks, generally 6-ft wide with a 5-ft buffer. Curb ramps are located on all corners; most do not have detectable warnings surfaces. As indicated in figure 2, Randle Circle is signed as a bike route; however, there is no dedicated bike lane. A dedicated bike lane is located along Massachusetts Avenue.

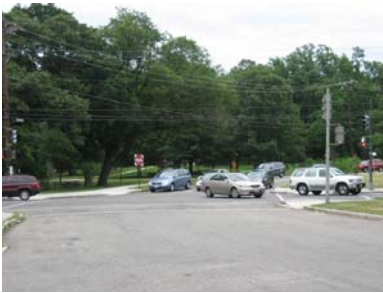
Figure 3: Minnesota Avenue at Northern end of circle

**Traffic Control:** All intersections around Randle Circle are unsignalized, with the exception of Minnesota Avenue (north), as shown in figure 2. This intersection is signalized with pedestrian signals and countdown timers. At the time of our site visit, there were minimal pavement markings. Figure 3 illustrates two lanes of traffic turning west on to Minnesota Avenue and one lane turning east. There were no signs or road markings informing drivers of this movement.

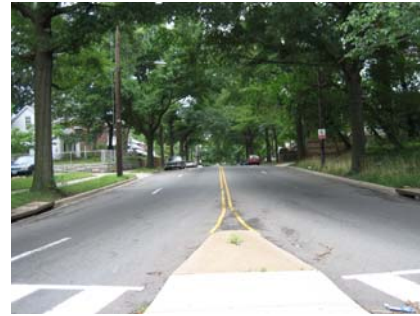
**Figure 5: Branch Ave at Randle Circle**

**Geometry:** It is a two-way, two-lane road with a 10-ft-wide inner lane and 9-ft-wide curbside lanes. The horizontal alignment of Branch Avenue is straight; however, the vertical alignment has a few curves, as figure 5 shows. Figure 5 also illustrates poor sight distance for pedestrians in crosswalk. The curb radii are generally 15 to 25 ft.
